TECHNICAL BULLETIN PL:BECS 072100-053118.1: FOAM-FILLED FOLLY

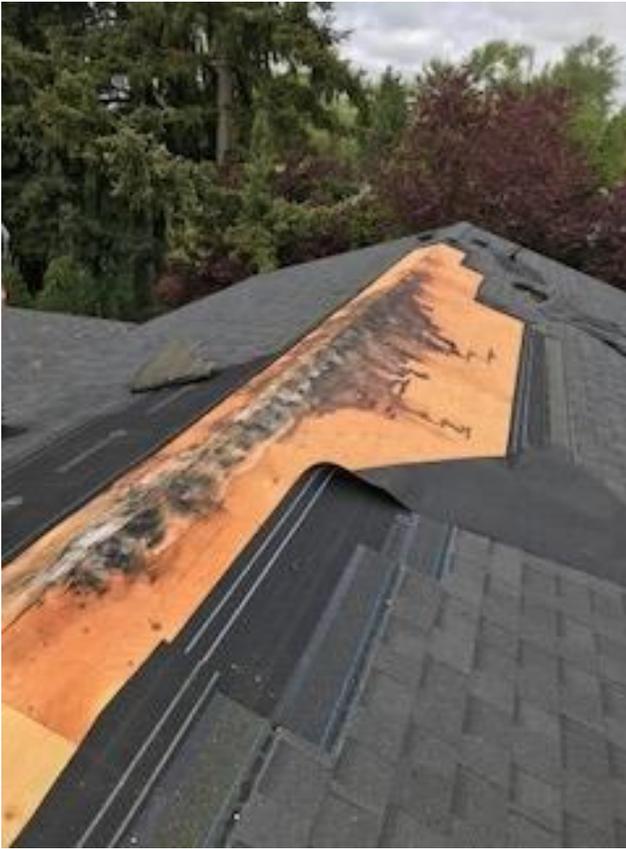
This changed when I was called out to a home with a 2-year-old addition which used such a roof assembly. The owner reportedly began noticing staining and dripping from the ceiling, and when the builder investigated, moderate decay was uncovered along the roof ridge above the enclosed space. Removing the plywood roof sheathing uncovered the foam-filled cavities, revealing that the foam in all but one cavity had shrunk and pulled away from the framing, opening large gaps, ranging up to 1 ½” wide, through which moist interior air could migrate unimpeded into the cavities, with no place to go from there. Consequently, fungal decay was well on its way along the ridge top in spite of this roof’s relatively young age. Although several very warm dry days had followed the removal of the plywood sheathing, allowing the moisture to dissipate prior to my arrival, moisture readings in the framing upon my arrival still ranged between 26% and 40%, indicating saturation of the lumber. In short, this home’s symptoms exactly matched those I expected to begin encountering with increasing frequency as this roof assembly approach becomes more widespread.

Fig. 1: Fungal Decay Along Ridge

I repeat my strong recommendation that this foam-filled, unvented roof cavity approach be avoided in favor of properly designed, properly vented assemblies with both high and low vents providing ample air flow for each framing bay. Figures 1-8 illustrate the observations made at the home cited in this bulletin.

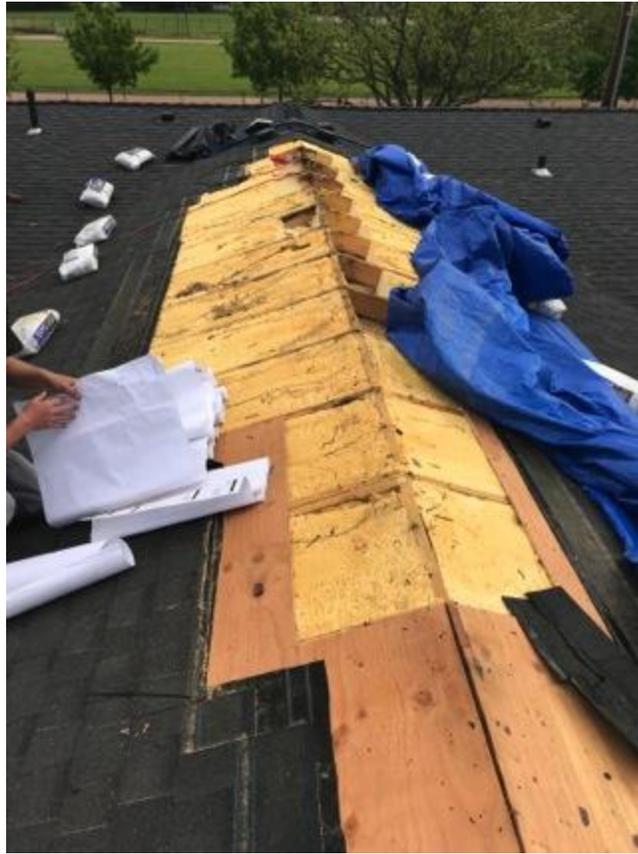
Fig. 2: Foam-Filled Over-Framing

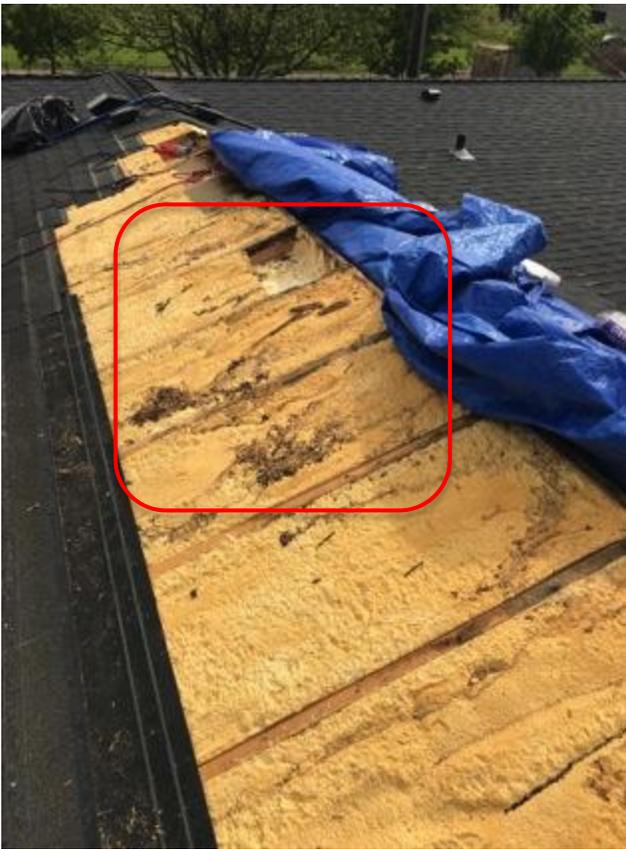
Fig. 3: Stained Foam Insulation

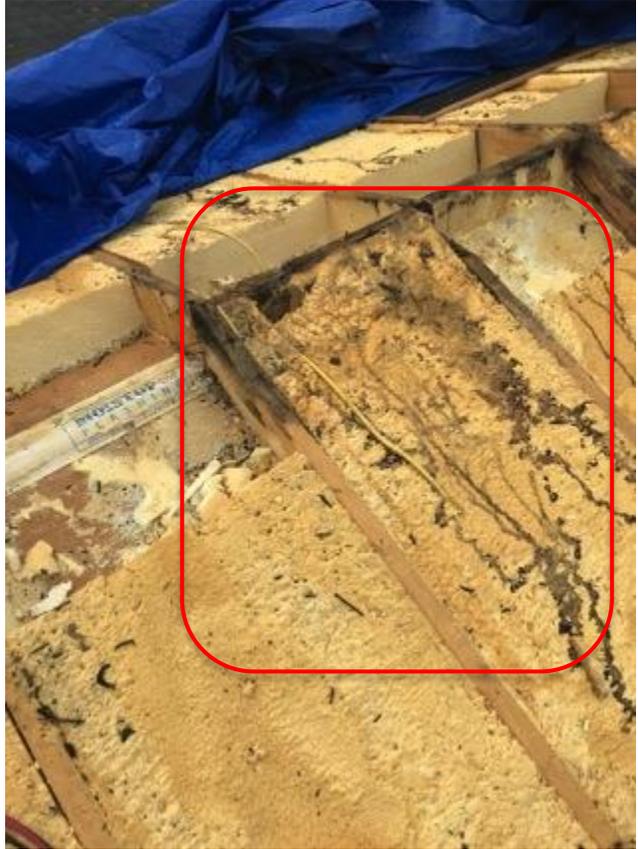
Fig. 4: Stained Foam Insulation

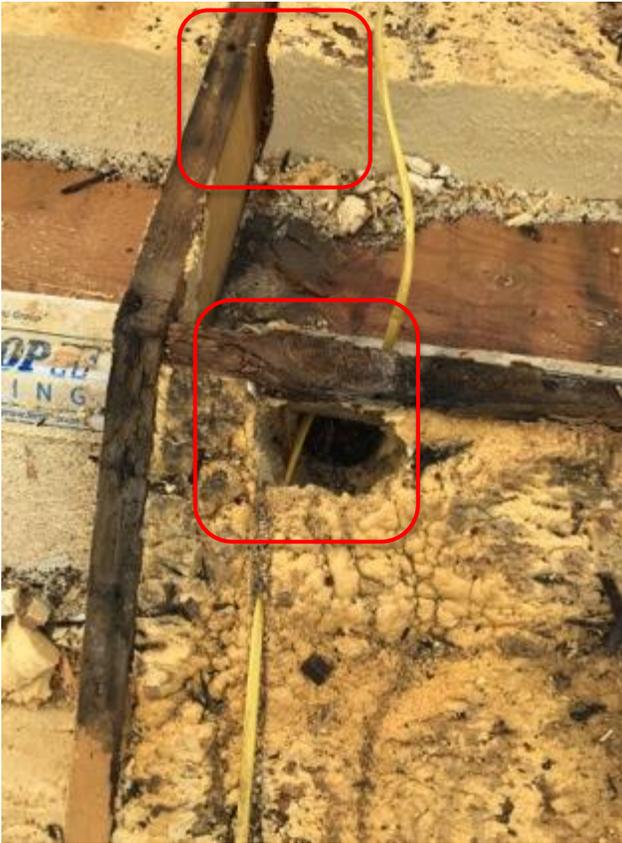
Fig. 5: Gaps at Wiring & Along Foam Edge

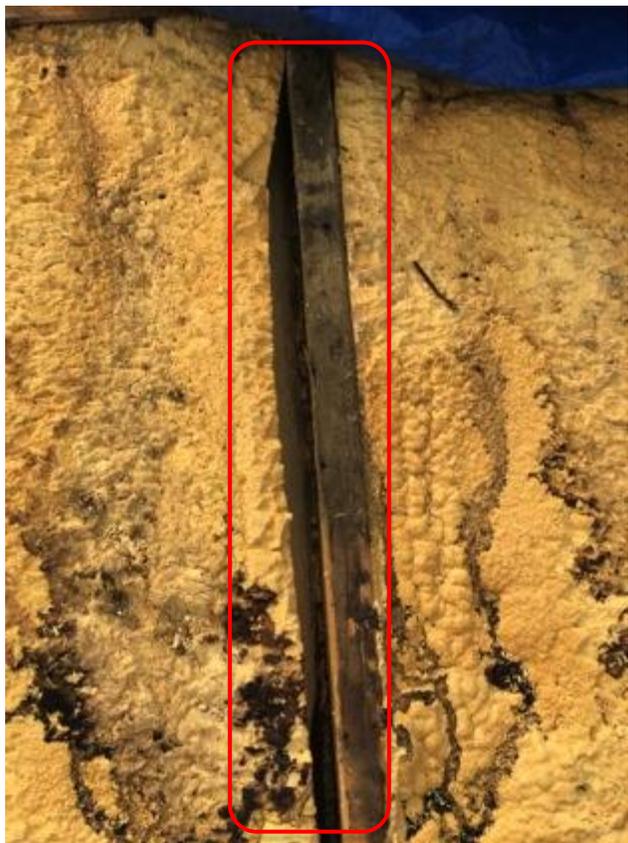
Fig. 6: Stained Foam Insulation, Foam Shrinkage

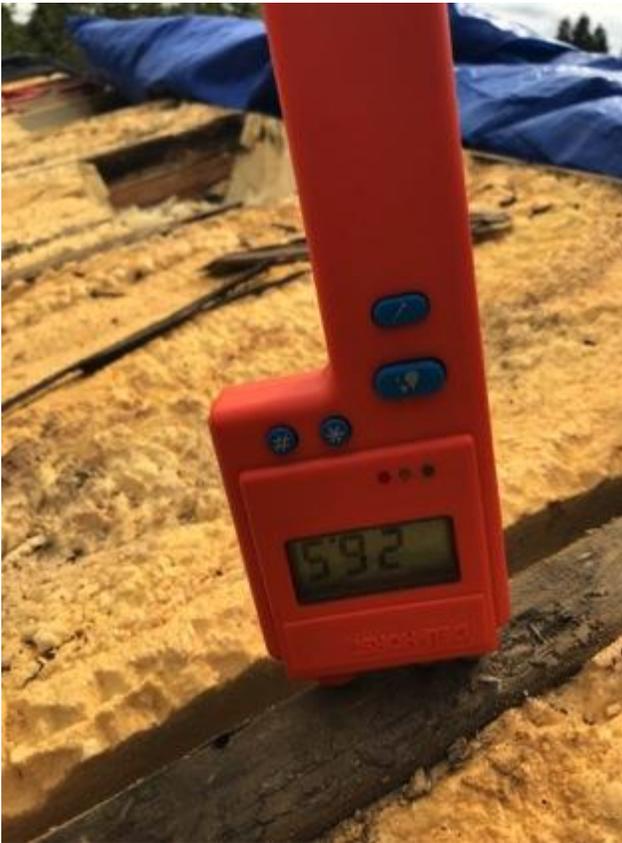
Fig. 7: Elevated Moisture Content, Decay

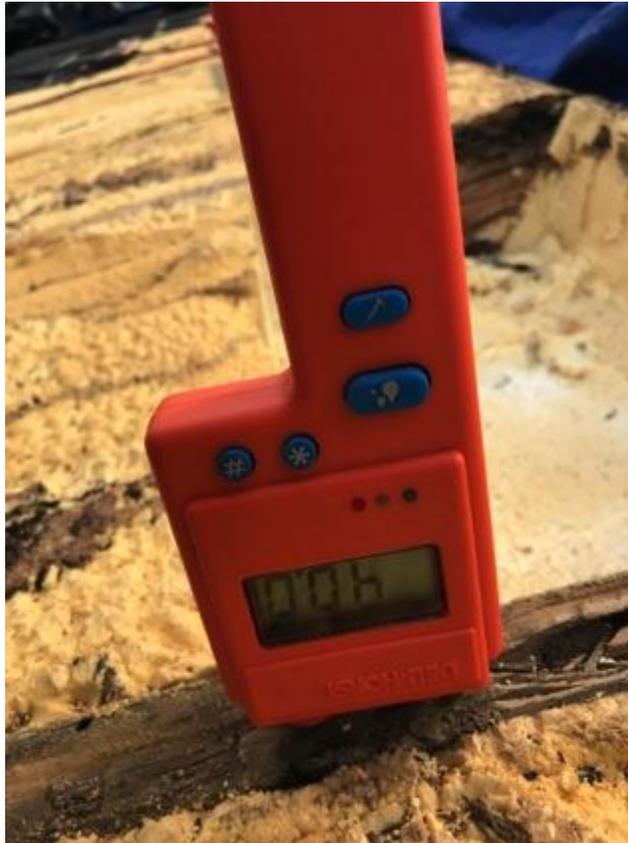
Fig. 8: Elevated Moisture Content, Decay
